## Sinton Industrial Site

Corpus Christi Regional Economic Development  
Corpus Christi, Texas

Terracon Project No. GR205649  
December 4, 2020

### SUMMARY OF FINDINGS

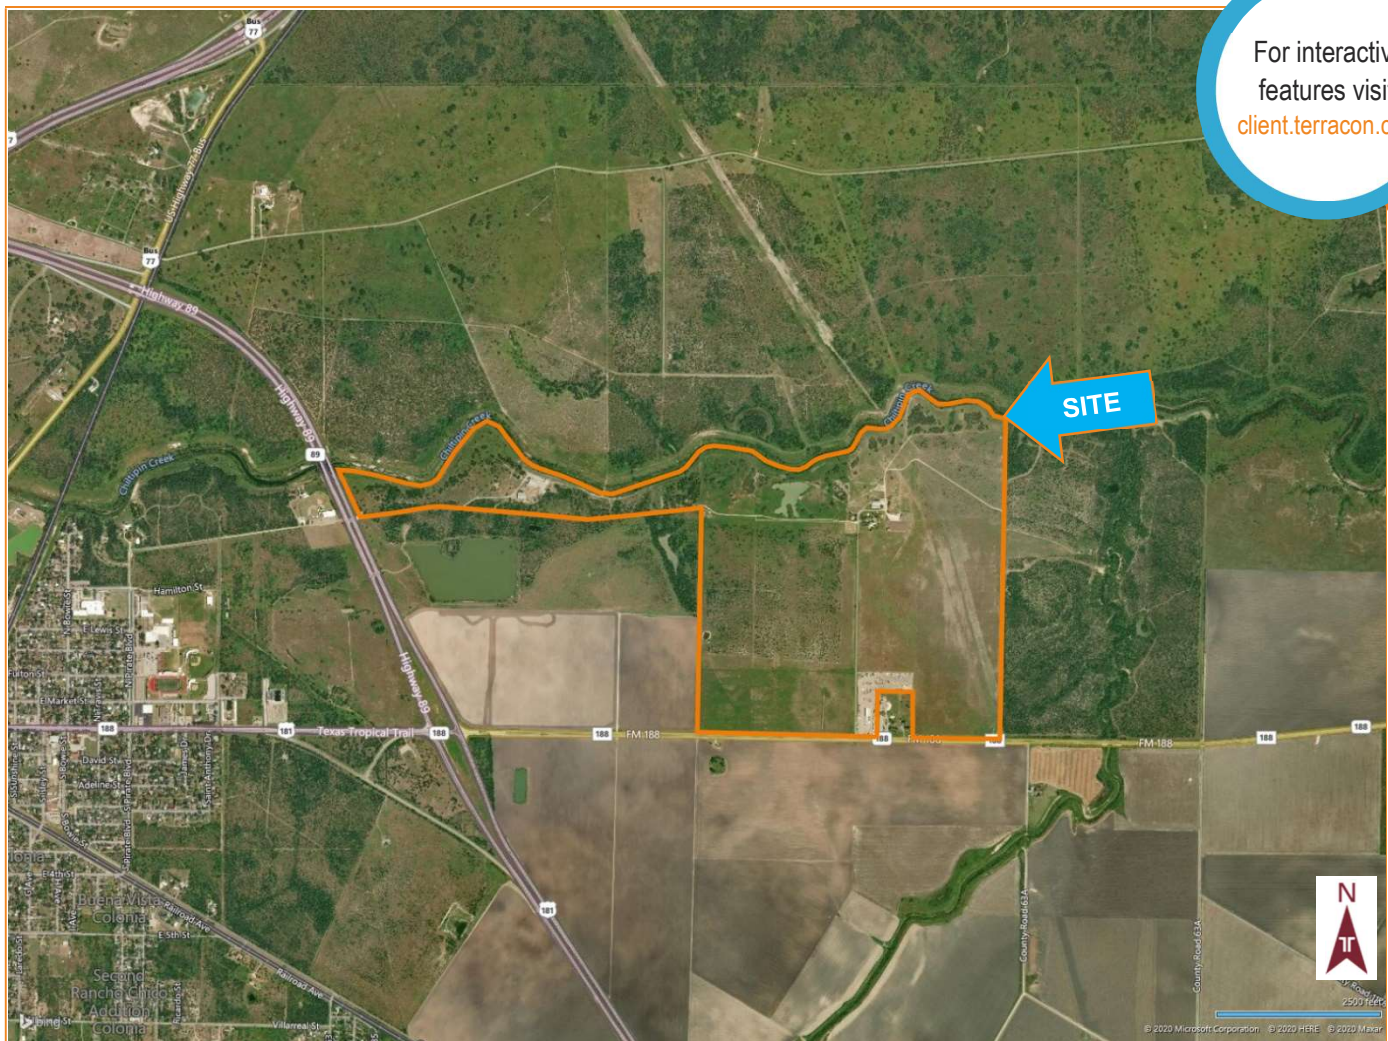
- The proposed site covers approximately 570 acres and is planned to be a future industrial development. We understand that the development may contain extensive paved parking areas and driveways.

See **INFORMATION SOURCES** for a detailed list of sources used to generate this figure.

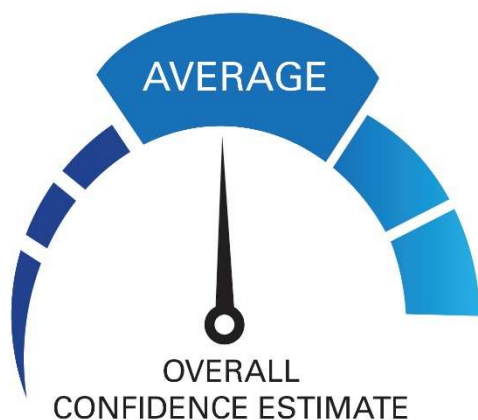
We have used a weighted average approach, please refer to [METHODOLOGY AND LIMITATIONS](#).

AVERAGE  
CONFIDENCE

We examined 3 [historical projects](#) within a 1 ¼ -mile radius.

Available [public data](#) is consistent with our understanding of the area.

INCREASED  
CONFIDENCE

Practitioner has [local experience](#) in excess of 28 years.

Using a weighted averaging approach, we derived an overall confidence interval in which historical project data was weighted more heavily than local experience which was weighted more heavily than public data. Decreased confidence implies that the level of available data and/or consistency is such that little confidence can be placed in the Geotechnical Considerations. Conversely, an increased confidence ranking implies that sufficient data and consistency exists to derive a high confidence in the statement of expected lithology.
